*IMPACT OF KOKOMO BY-PASS  
FROM 1950 TO 1964*

*AUGUST 1965*

*Joint  
Highway  
Research  
Project*

*by*  
*E.G. EVANS*

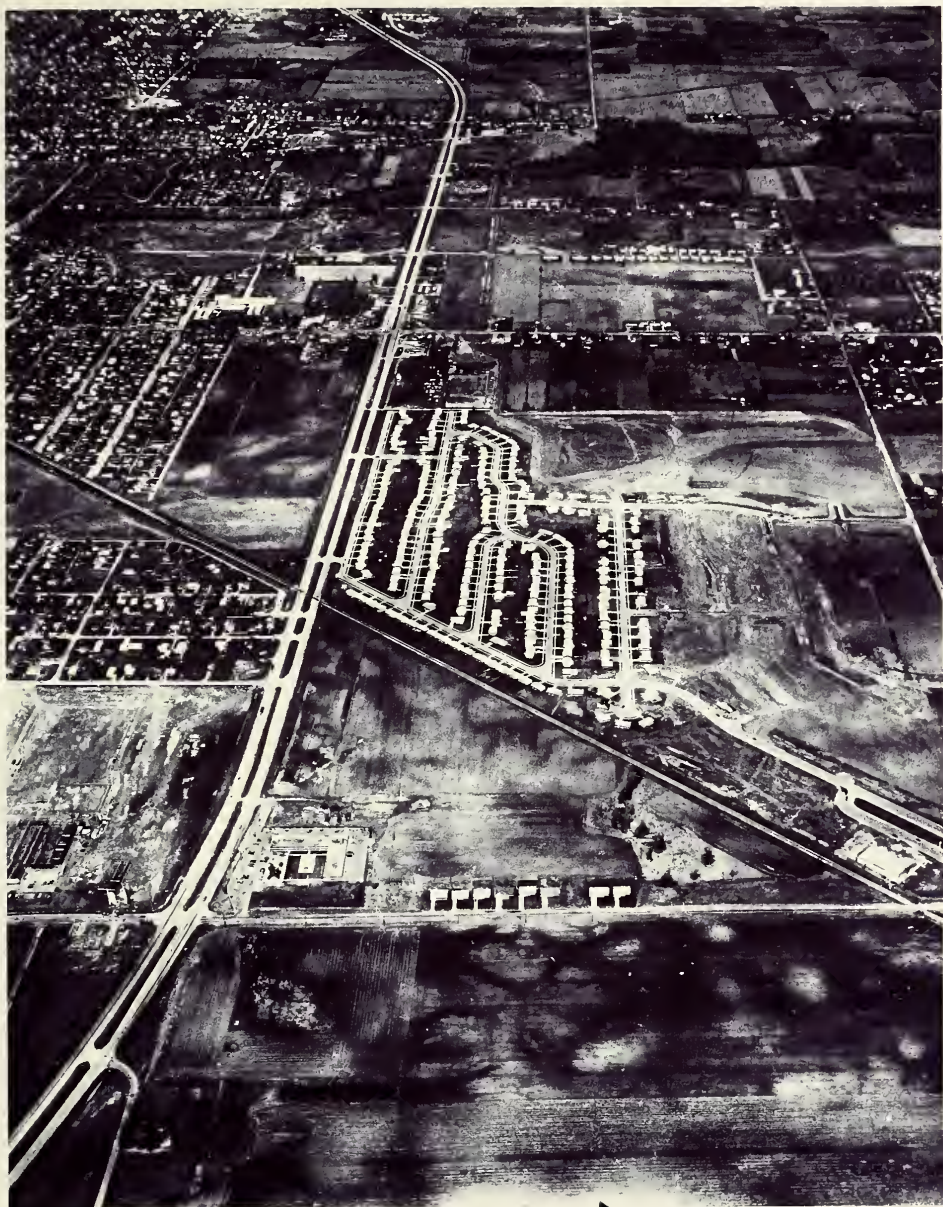
FIGURE 8- A PORTION OF THE KOKOMO BY-PASS IN 1963

An aerial photograph taken in 1963 of a portion of the by-pass is shown in Figure 8.

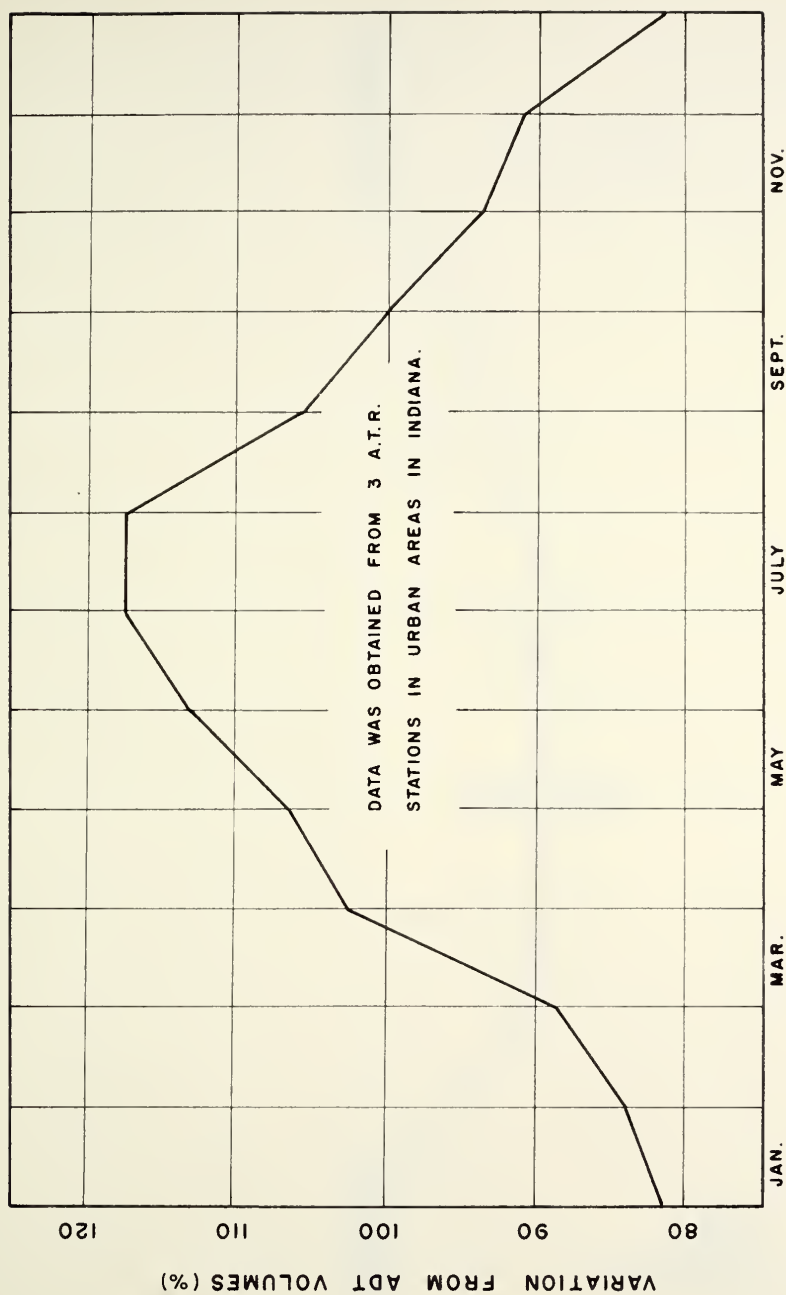
FIG. 9- VOLUME FACTORS FOR MONTHS OF THE YEAR.

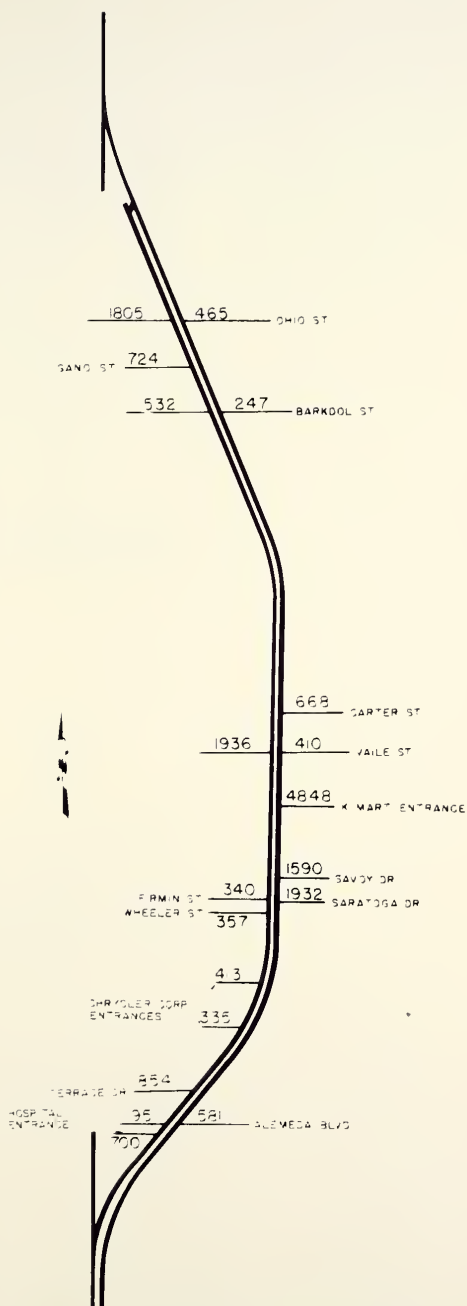
FIGURE 12 - TRAFFIC VOLUMES ON MINOR STREETS IN 1964

Volumes in 1951 for the Kokomo By-pass and major intersecting streets are shown in Figure 10. When these are compared to the corresponding volumes in 1964 (see Figure 11), a sizeable increase in volumes is noted. Figure 12 shows pictorially the volumes at minor intersections and access points along the by-pass. Increases in traffic volumes from 1951 through 1964 for selected locations on the by-pass and on streets intersecting the facility are also shown in Tables 4 and 5.

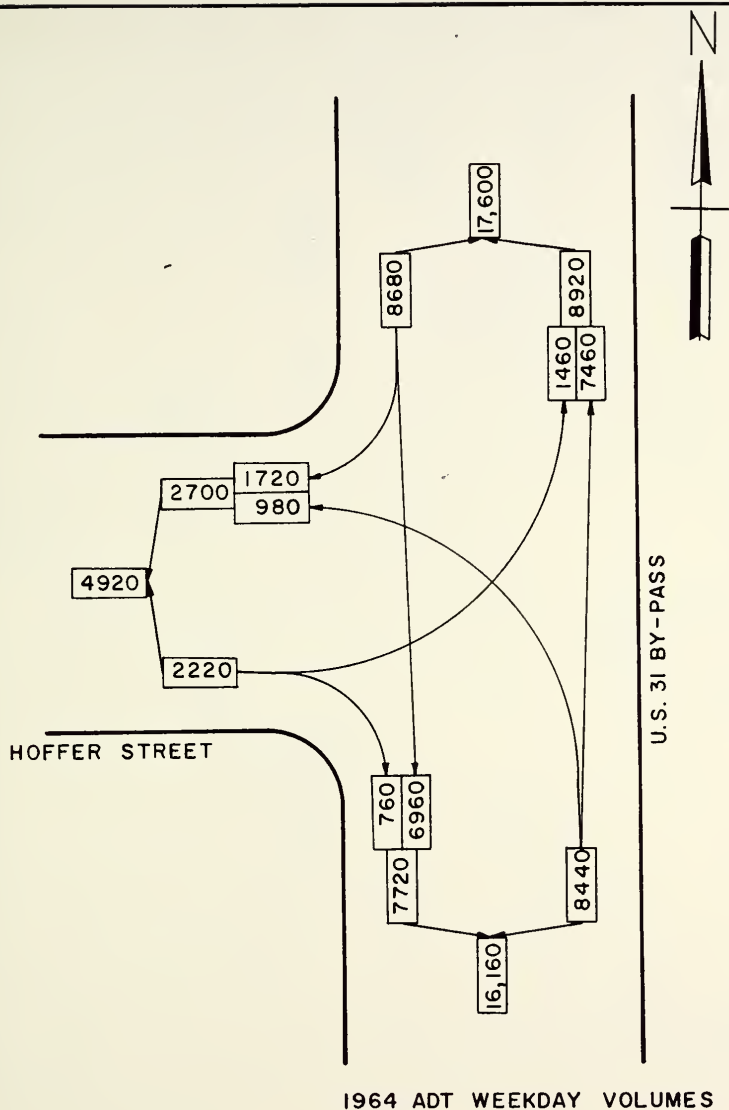
**FIG.19 - VOLUME AND TURNING MOVEMENTS  
AT HOFFER STREET AND U.S. 31 BY-PASS**

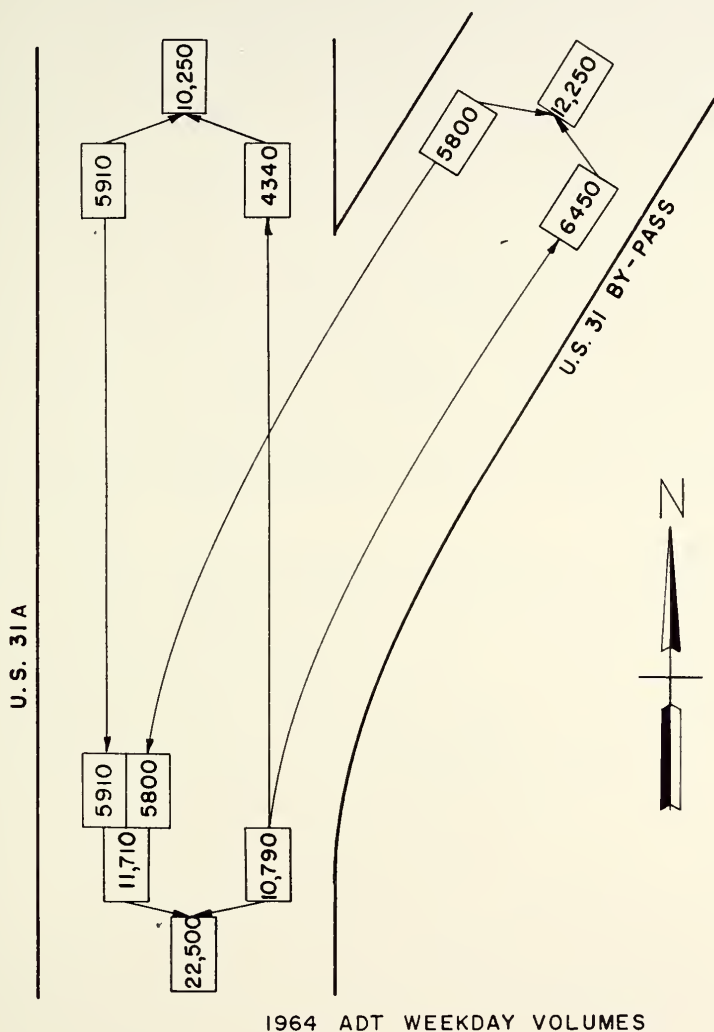
FIG.24- VOLUME AND TURNING MOVEMENTS  
AT THE SOUTH JUNCTION OF U.S. 31A  
AND U.S. 31 BY-PASS

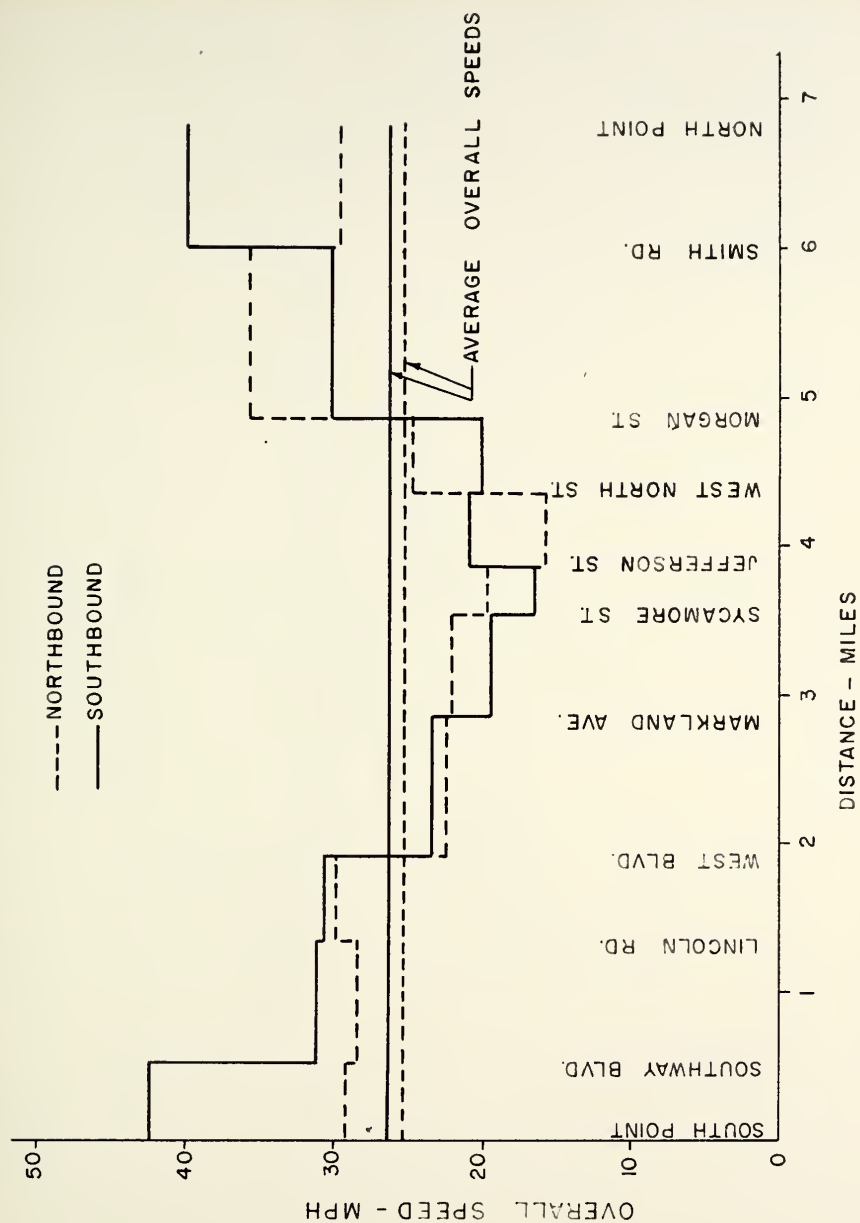
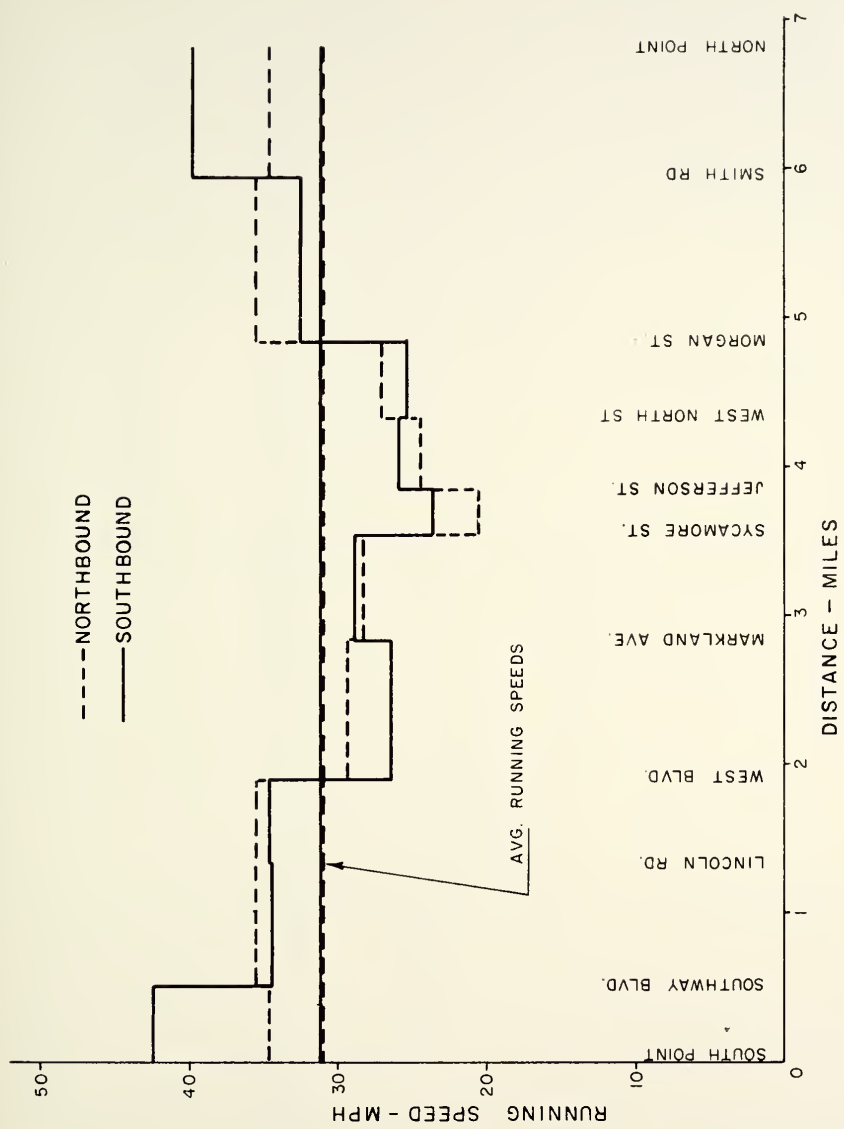
FIG. 25 - SPEED-DELAY FOR KOKOMO CITY ROUTE

FIG.26 - SPEED-DELAY FOR KOKOMO CITY ROUTE

Eight test runs were made in each direction on the city route of U.S. 31 and twenty-seven runs were made on the Kokomo By-pass. The results of these runs are presented in Figures 25, 26, 27, and 28. Figures 25 and 26 represent overall and running speeds for the sections on the city route while Figures 27 and 28 show overall and running speeds for the by-pass facility. Travel times for the calculations of running speeds were obtained by subtracting the stopped time from the times recorded from the continuously running watch for each section of highway. From Figures 25 and 26 it is seen that the greatest delay was encountered between West Boulevard and Morgan Street. This is the portion of the city route which contains traffic signals, railroad crossings, dense development, and congestion during peak volume periods -- all of which increase travel time and reduce speeds.

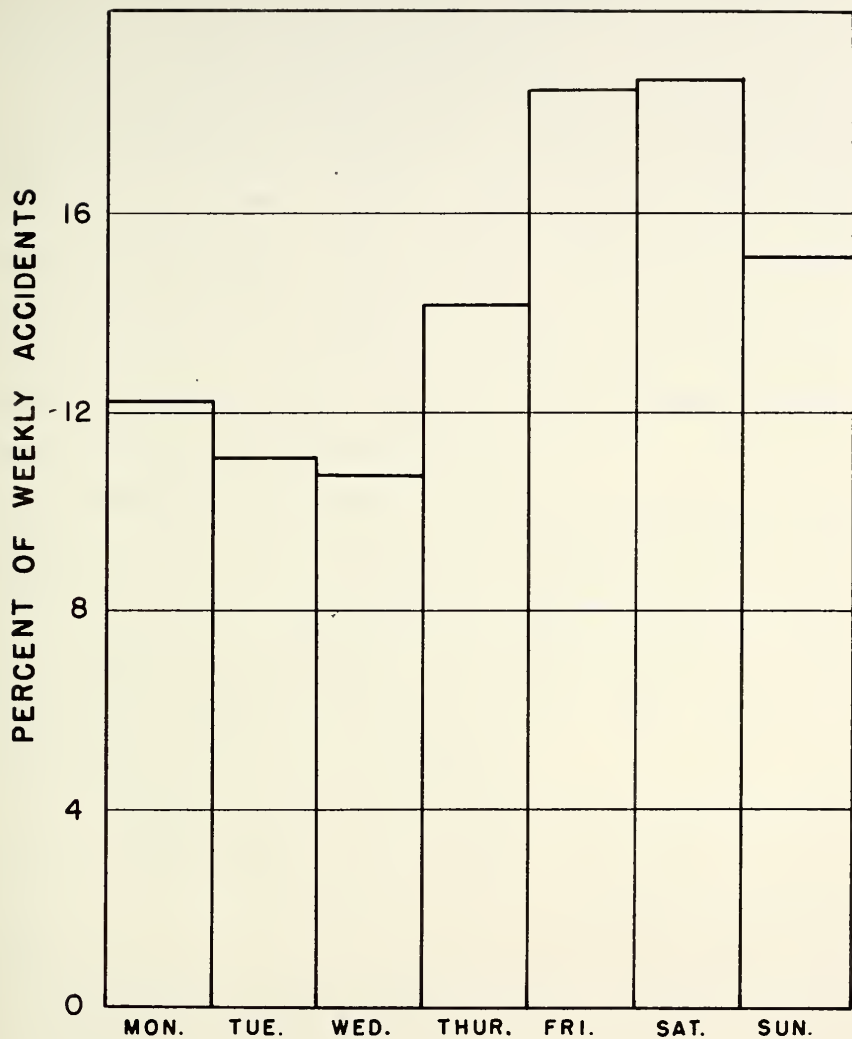
FIG. 33-TRAFFIC ACCIDENT DISTRIBUTION ON  
THE KOKOMO BY-PASS BY DAY OF  
WEEK FOR 1961, 1962, AND 1963.

The accident occurrence on the Kokomo By-pass by day of week is typical to the curve found for most urban sections of highway (see Figure 33). The percentage of weekly accidents is highest on Friday and Saturday. Traffic volumes, which

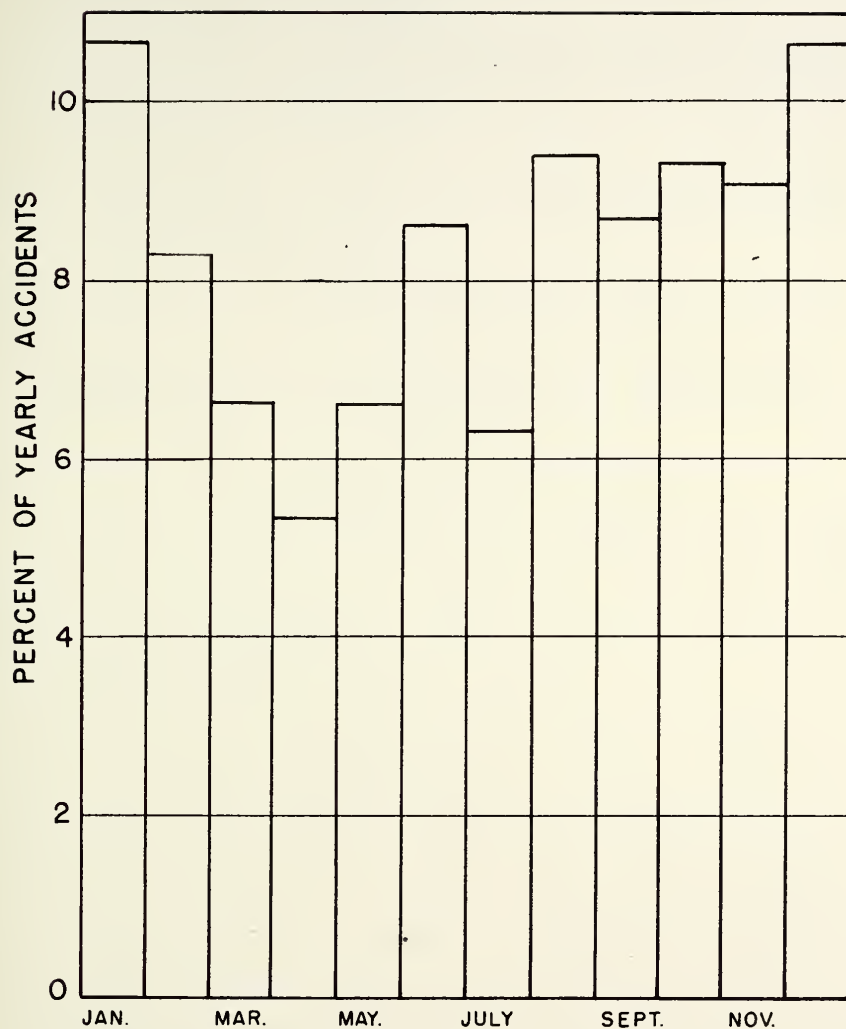
FIG. 34 - TRAFFIC ACCIDENT DISTRIBUTION ON THE  
KOKOMO BY-PASS BY MONTH OF YEAR  
FOR 1961, 1962, AND 1963.

Autumn and winter months were the most conducive to traffic accidents (see Figure 34). Traffic volumes are lowest for the winter months, however. This means that the accident rate is highest during the autumn and winter. An investigation of the causes of high accident rates in the winter months revealed that many accidents were of the rear-end type at signalized intersections. Many of these accidents occurred under slippery pavement conditions.

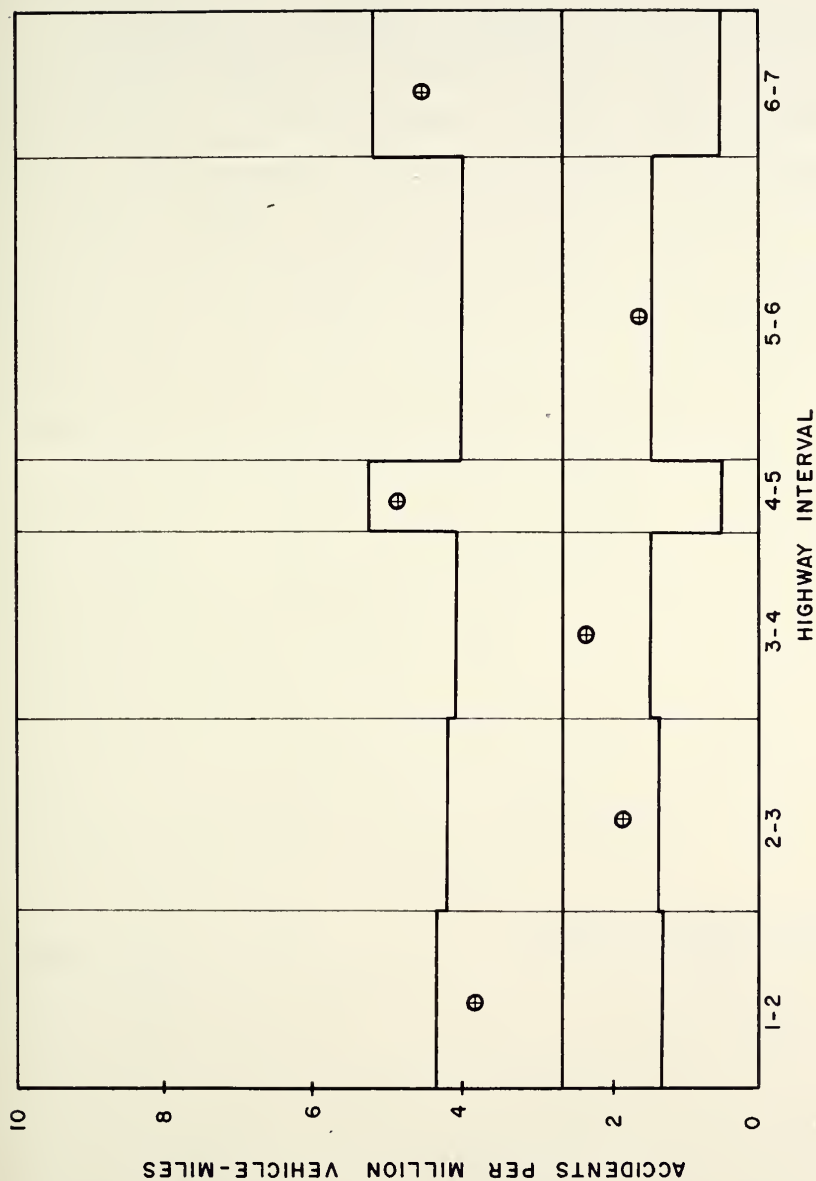
FIG. 37- CONTROL CHART OF SECTION ACCIDENT RATES FOR SOUTHBOUND TRAFFIC DURING 1961, 1962, AND 1963.

For section 1-2 the southbound traffic is channelized at approximately Alto Road to the inside lane to minimize the conflict between merging traffic at the south end of the by-pass. No left turning lane has been provided for the southbound by-pass traffic wishing to turn left at Alto Road. This means that both through and left turning traffic use the inside lane, and this has resulted in several rear-end collisions. A study of the accident records indicates that

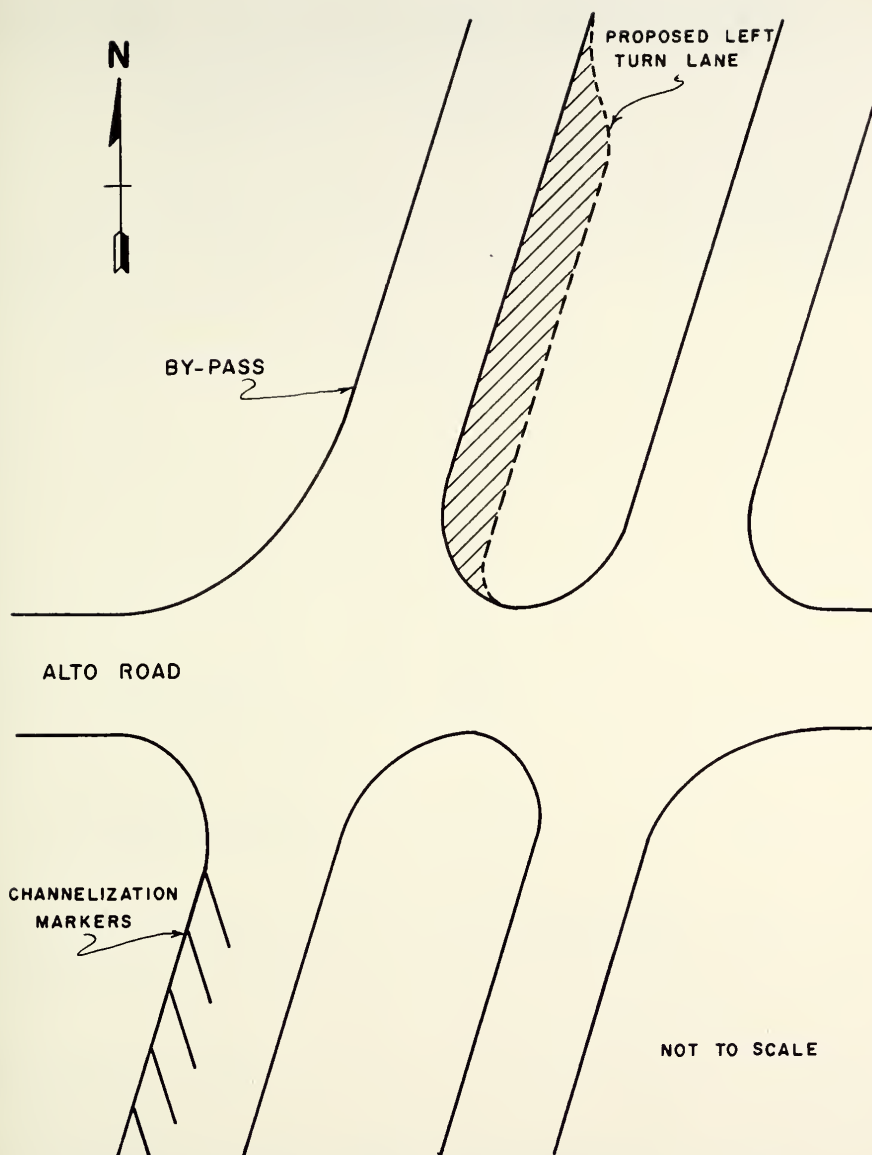
FIG. 38- PROPOSED ADDITION OF A LEFT TURNING LANE ON THE KOKOMO BY-PASS AT ALTO ROAD.

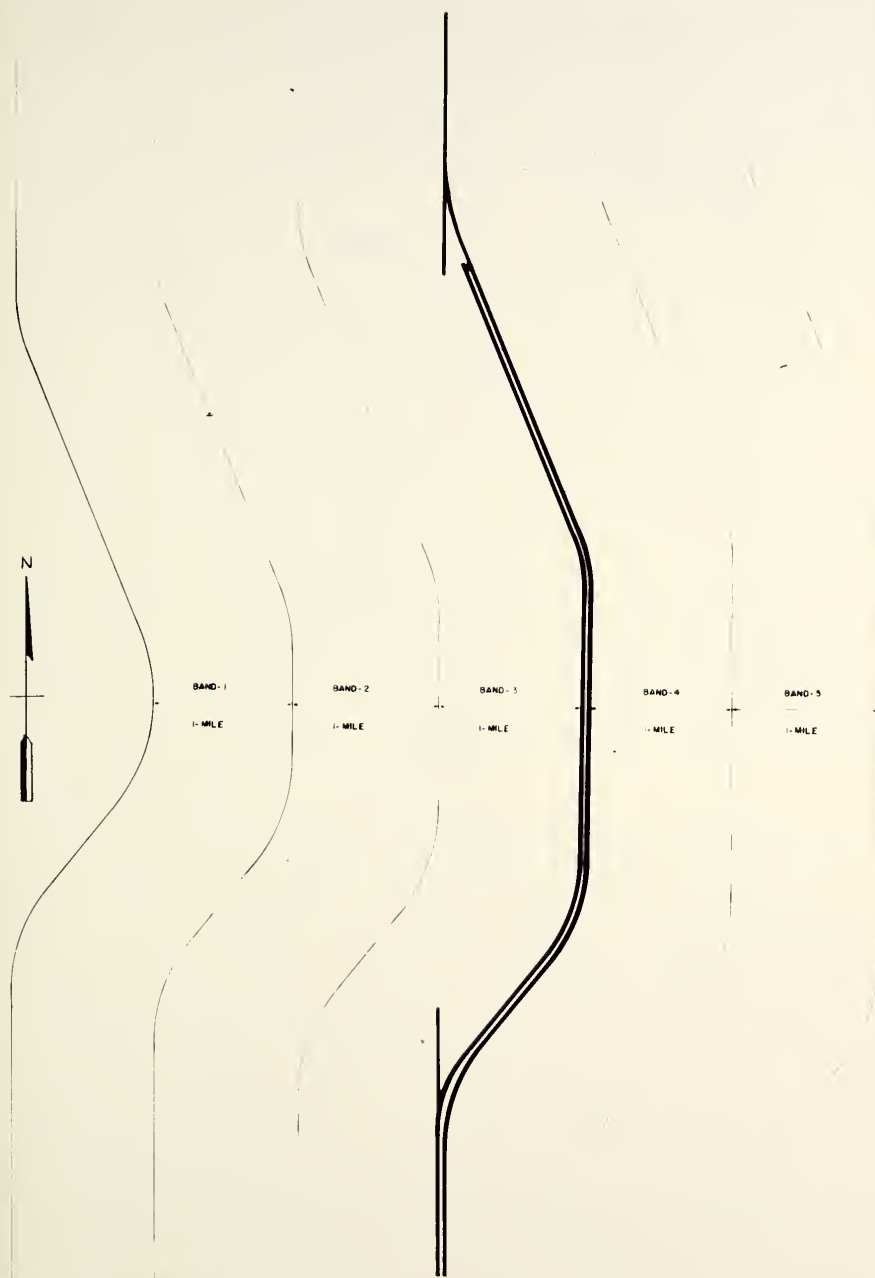
FIG. 60 - LAND VALUE BANDS PARALLEL TO THE BY-PASS

Band I - 2 to 3 miles west of the by-pass

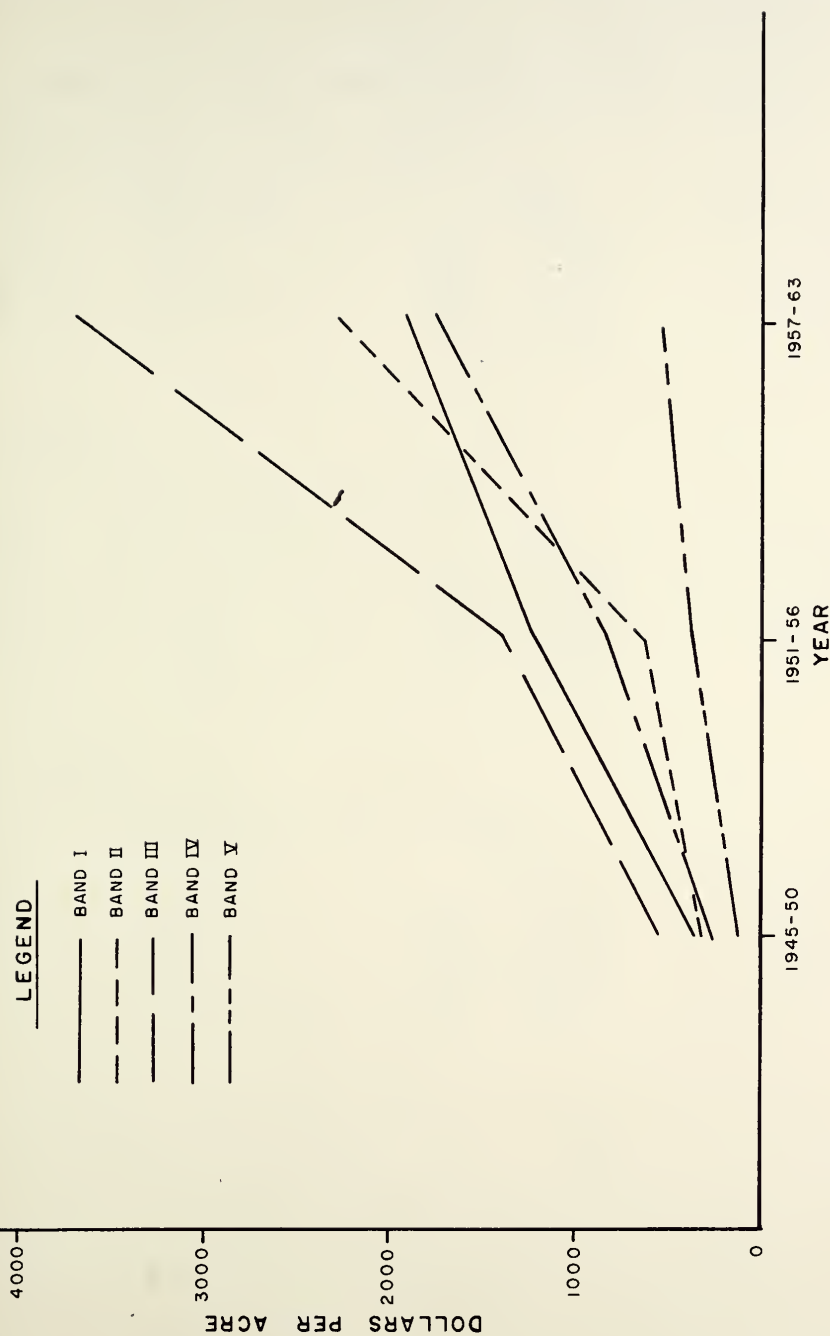
FIGURE 61 - MEAN VALUE PER ACRE OF LAND ALONG KOKOMO BY-PASS

Land in band II, which includes the central portion of Kokomo, did not increase in value in the period 1951-56 as much as land in band I, the suburban area, but the increase in value 1957 - 63 was much greater. This increase in land value in the central area of the city after 1956 may have been due to improved economic conditions in the city, and it may have also been due to exploitation by businessmen of areas along old U.S. 31 which were readily accessible to local traffic following the construction of the by-pass.

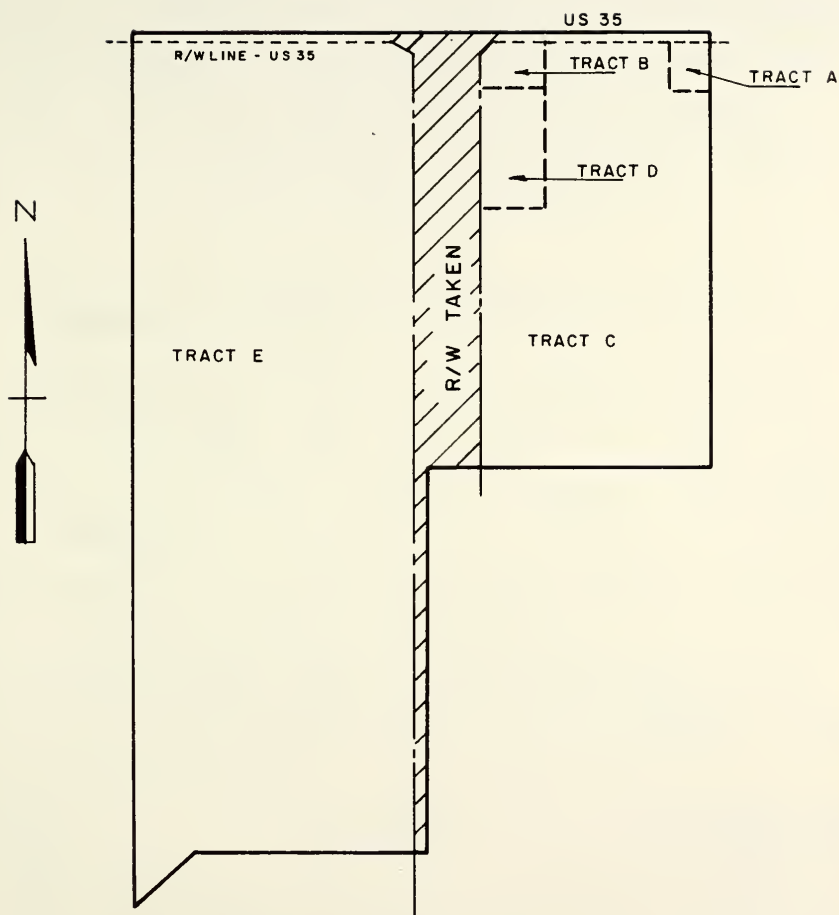
FIG.1-2 -PLAT OF SUBJECT PROPERTY SHOWING R/W TAKEN

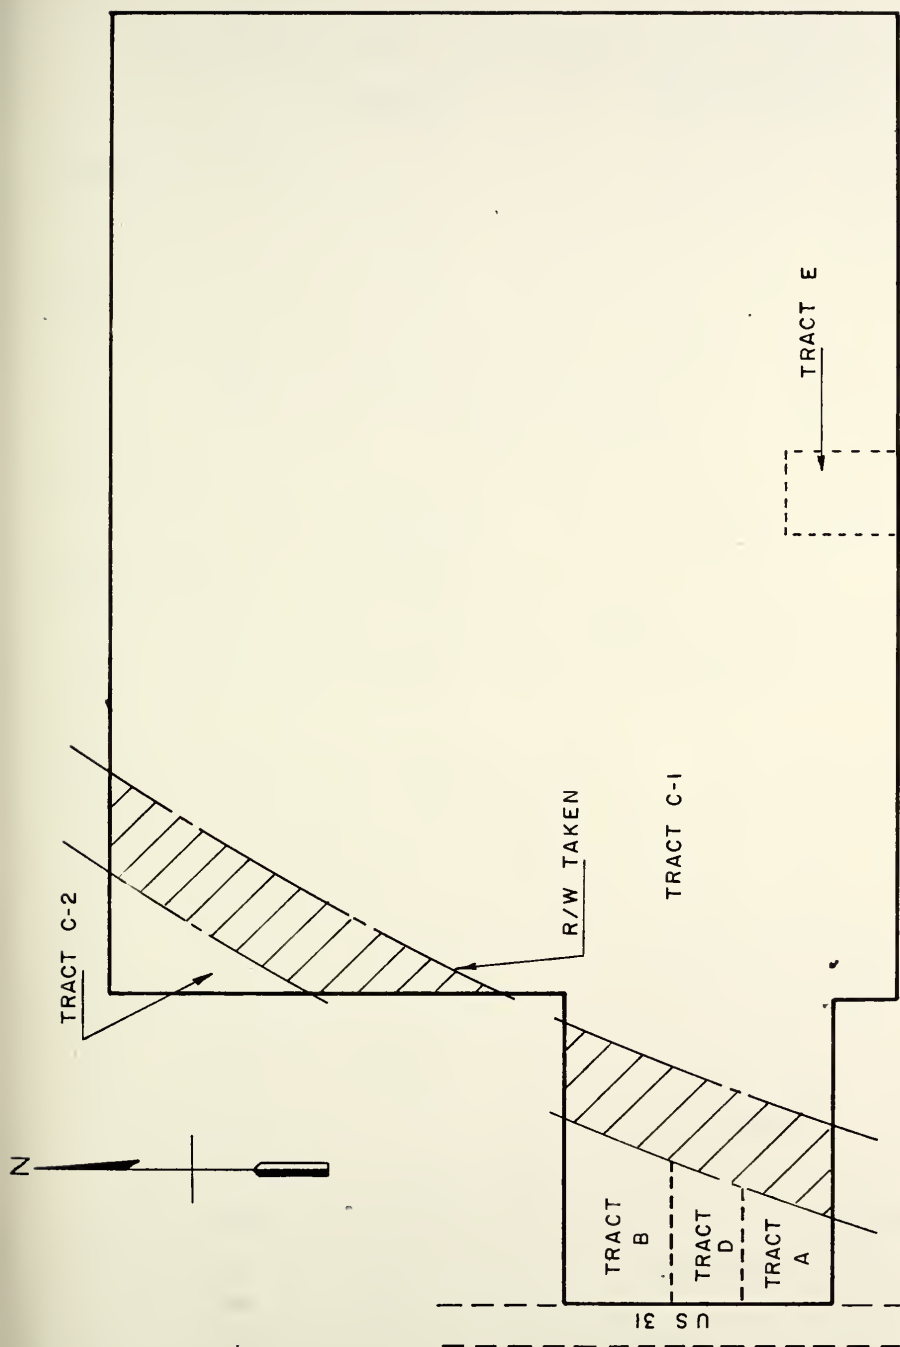
FIG.2-2 - RIGHT-OF-WAY ACQUIRED AND LOCATION OF TRACTS SOLD

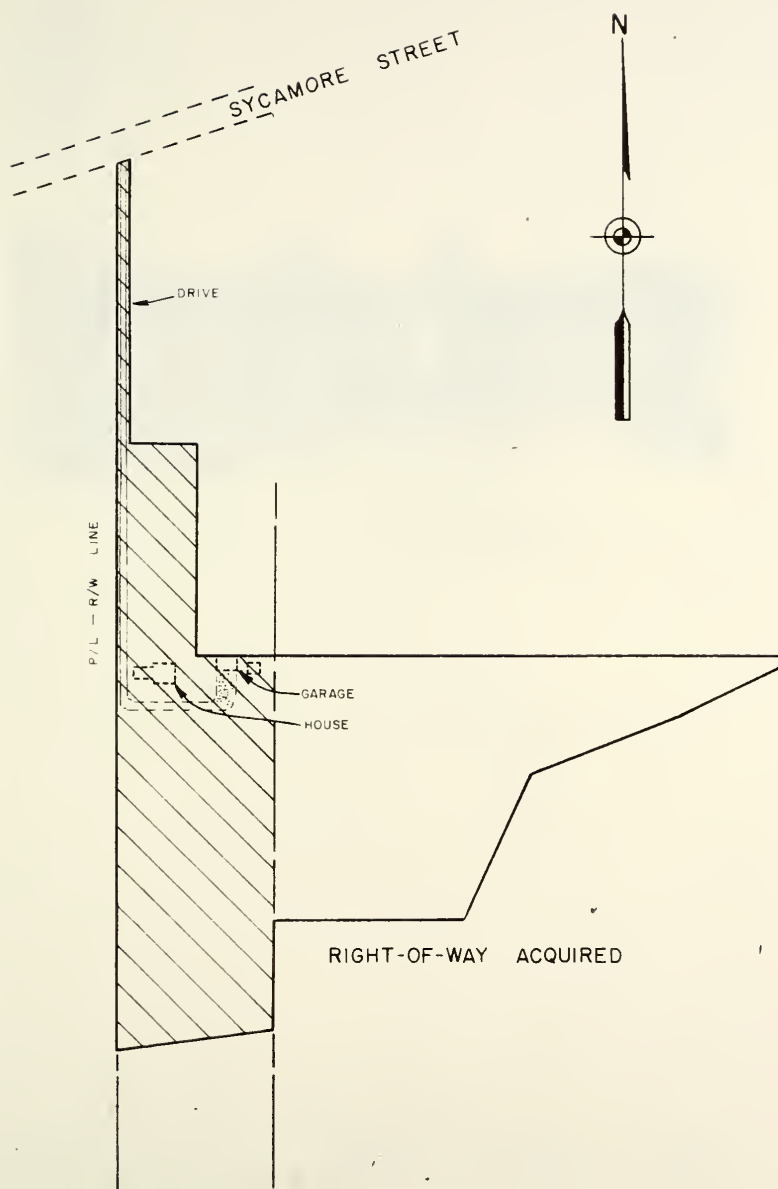
SUBJECT PROPERTY SHOWING RIGHT-OF-WAY TAKEN  
FIGURE 3-2

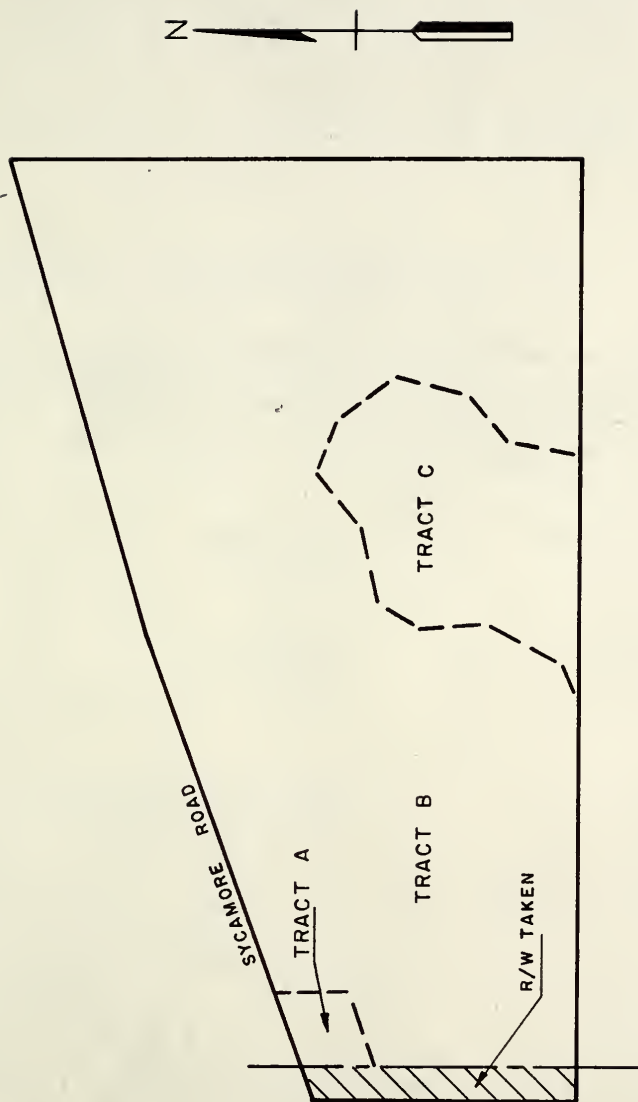
FIG.42-PLAT OF SUBJECT PROPERTY SHOWING RIGHT-OF-WAY TAKEN

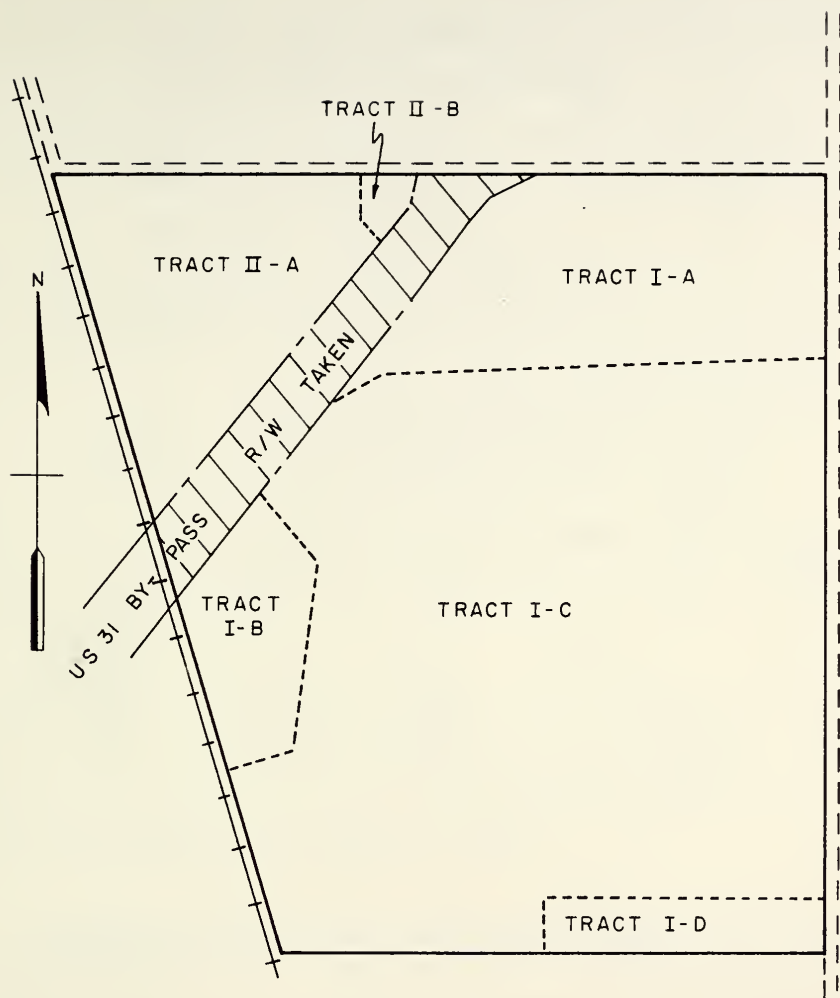
FIGURE 6-2 - RIGHT-OF-WAY ACQUIRED AND LOCATION OF TRACTS SOLD

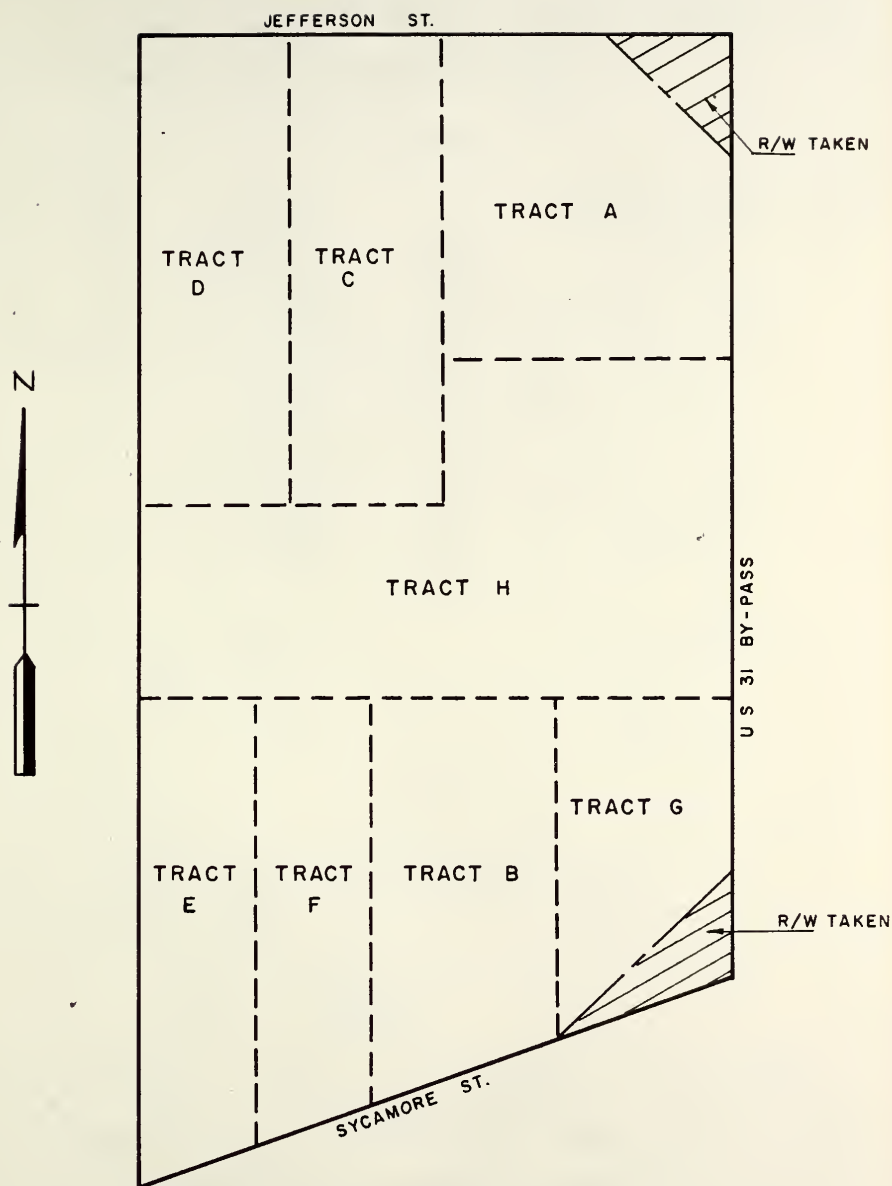
FIG. 7-2-PLAT OF SUBJECT PROPERTY SHOWING R/W TAKEN

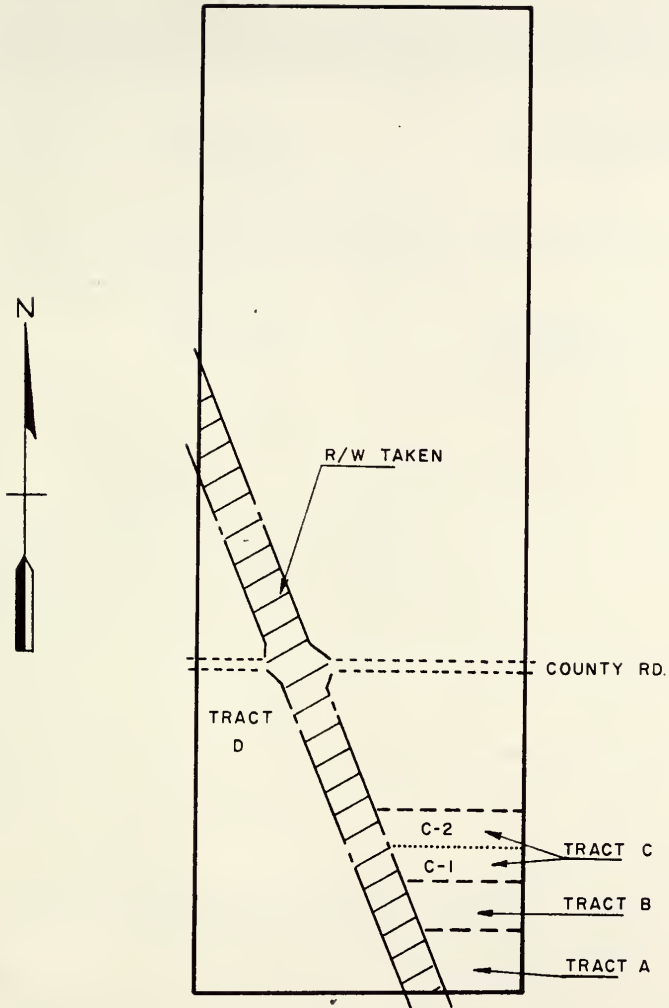
FIG.8-2 - RIGHT-OF-WAY ACQUIRED AND LOCATION OF TRACTS SOLD

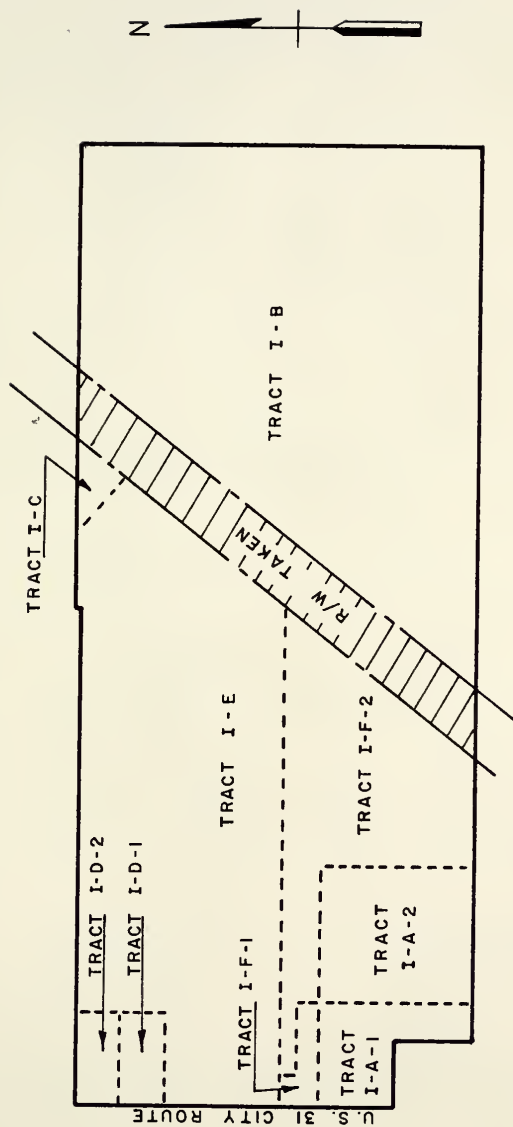
FIG. 9-2 - RIGHT-OF-WAY ACQUIRED AND LOCATION OF TRACTS SOLD
